SUMMARY

1234 Main Street Huntley IL 60142

Michael Hetzel  
InterNACHI Certified Professional  
Inspector  
Wisdom Home Inspection Services LLC  
(224) 817-1511  
Mike@WisdomHIS.com

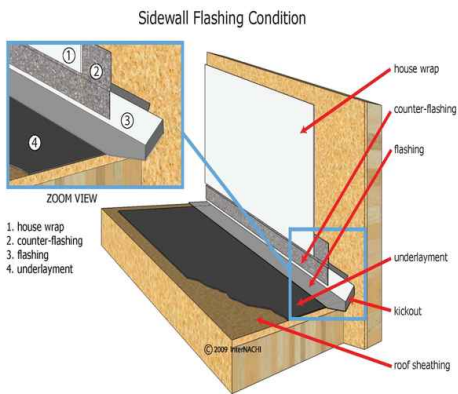
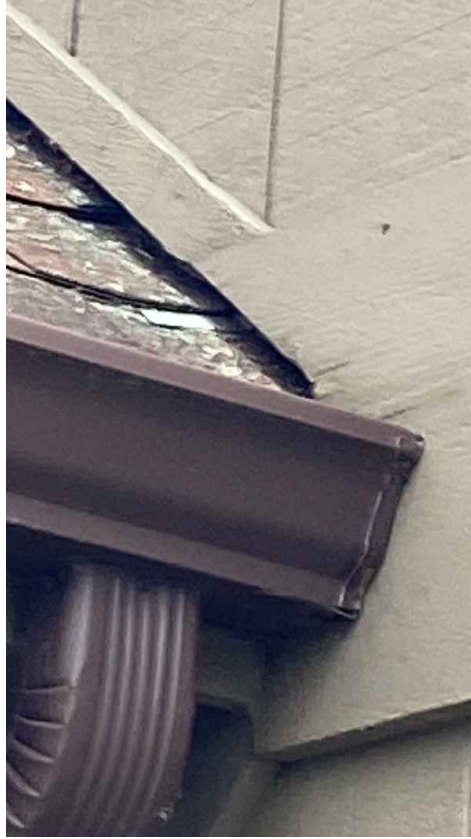
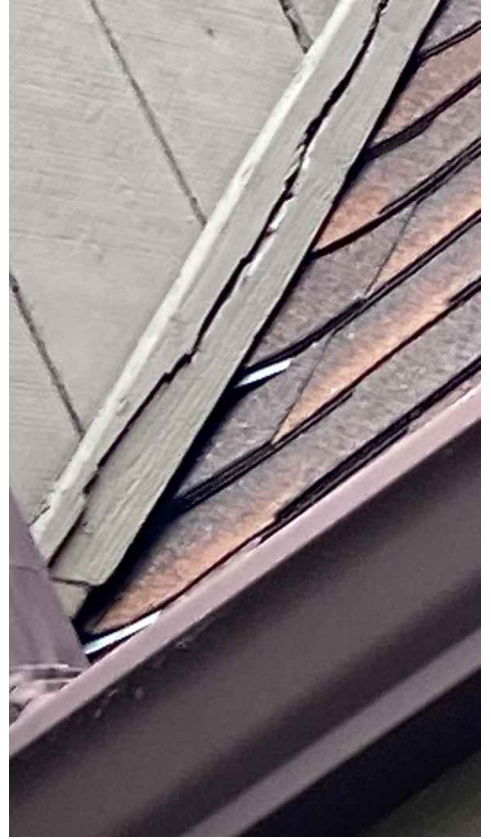
**MISSING SIDE WALL FLASHING**

I observed areas where flashing was missing. Not installed. Improper installation of flashing. These areas of missing flashing are prone to water penetration. Flashing is installed to provide protection against roof leaks and to divert water away from certain areas. Correction and further evaluation is recommended.

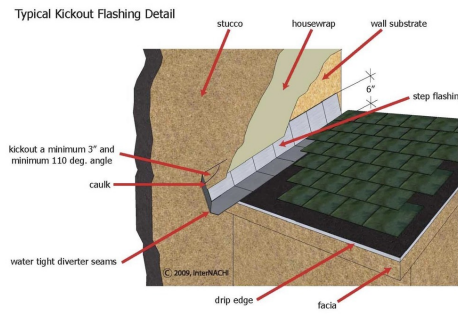
Kick-out Flashing

#### MISSING KICKOUT FLASHING

I observed a defect at the flashing area called a "kickout." It's missing. Not installed. A kickout flashing "kicks" the roof water away from the house structure and diverts it into a gutter. This missing flashing could lead to hidden moisture intrusion and water damage issues that I would not be able to observe during a visual-only home inspection. A roofing professional is needed to further evaluate and make necessary corrections.

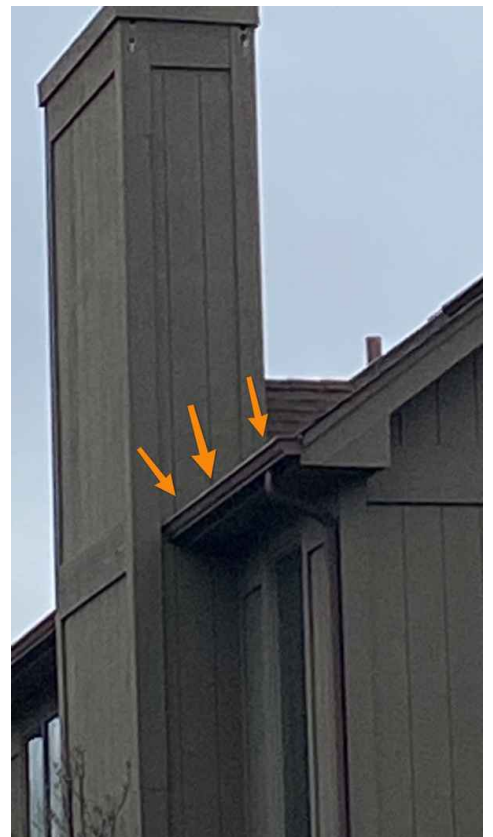
Missing Chimney Flashing

#### MISSING CHIMNEY FLASHING

It was observed that the chimney flashing was missing. If not installed, water intrusion will occur and which can lead to costly repairs.

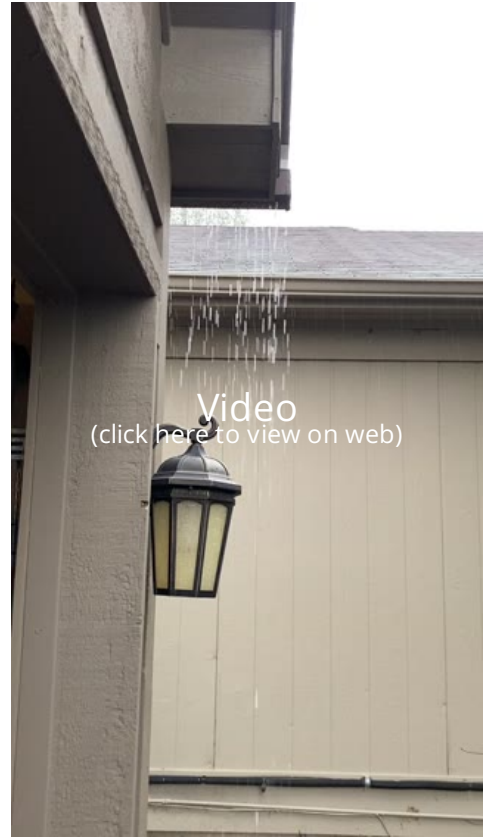
Garage

**DEBRIS IN GUTTERS**

I observed debris in the gutter. Cleaning and maintenance is recommended.

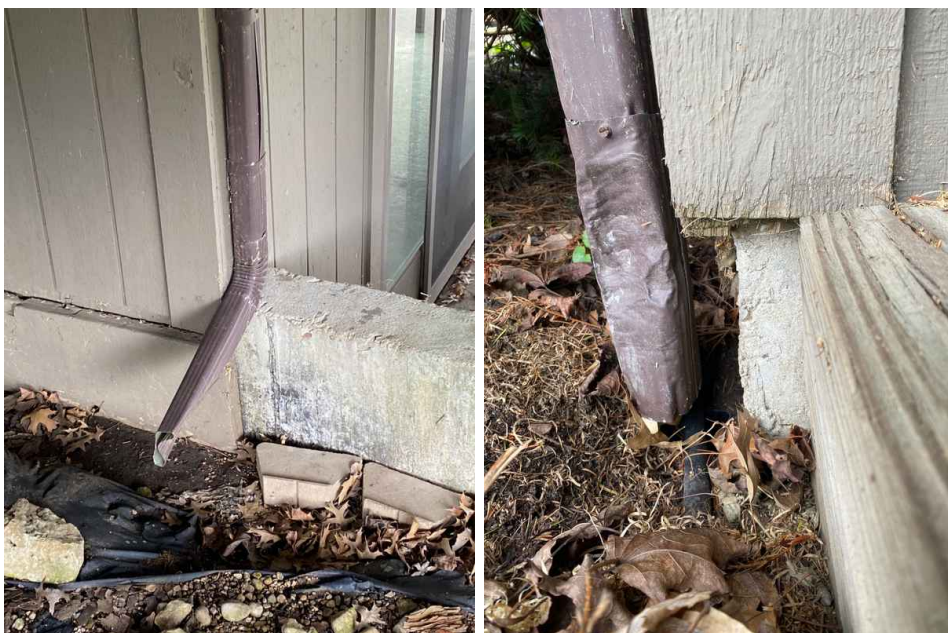
**DOWNSPOUTS DRAIN NEAR HOUSE**

One or more downspouts drain too close to the home's foundation. This can result in excessive moisture in the soil at the foundation, which can lead to foundation/structural movement. Recommend a qualified contractor adjust downspout extensions to drain at least 6 feet from the foundation. A handy homeowner should be able to do this project.

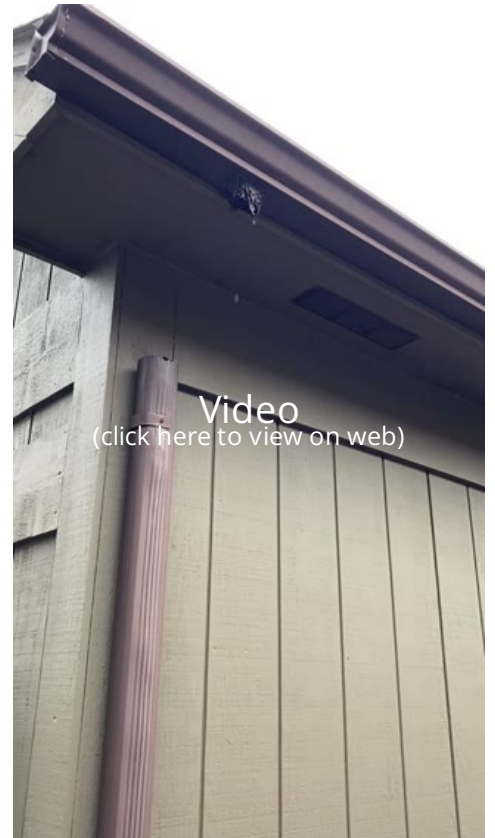
**DOWNSPOUT DETACHED**

I observed indications of a disconnected and detached downspout pipe. Easy fix.

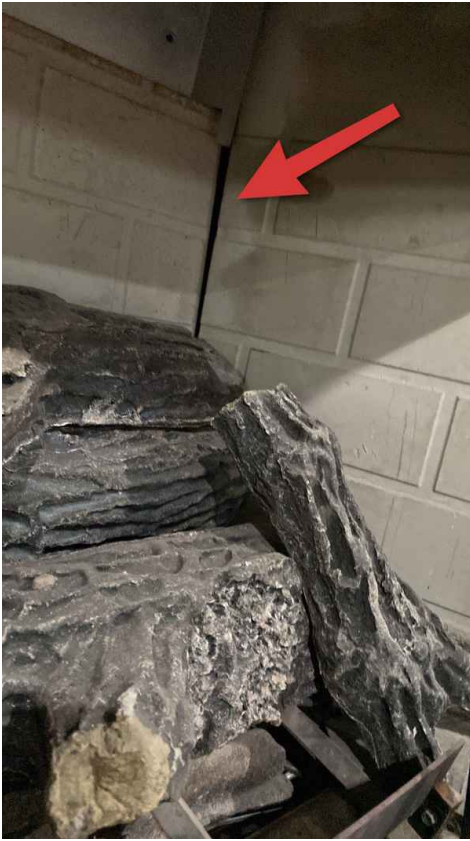
Basement Fireplace

**HEARTH DEFECT**

I observed indications of joint separation, damage, or deterioration of the hearth, hearth extension, or chamber. Before using this fireplace correction is needed by a qualified fireplace professional.

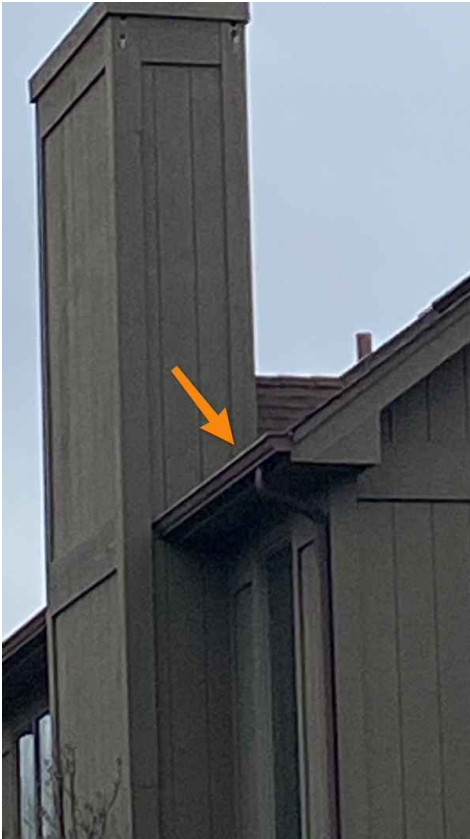
#### **CHIMNEY FLASHING DEFECT**

I observed a defect at the chimney flashing. Prone to water leaking at this area.

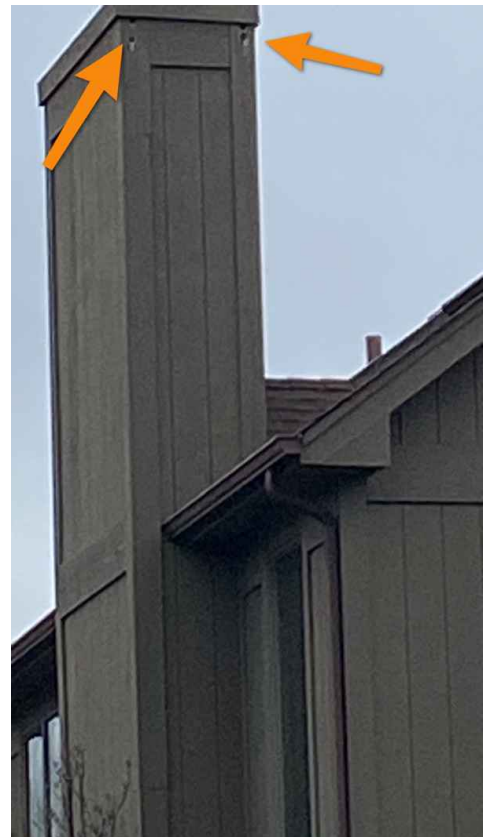
3.3.2 Factory-Built Chimney  
**DEFECT AT CHIMNEY EXTERIOR**

I observed indications of a defect at the chimney exterior materials. It is recommended that a qualified carpenter/contractor do further evaluation and repairs. If left unattended, costly repairs could result due to water penetration.

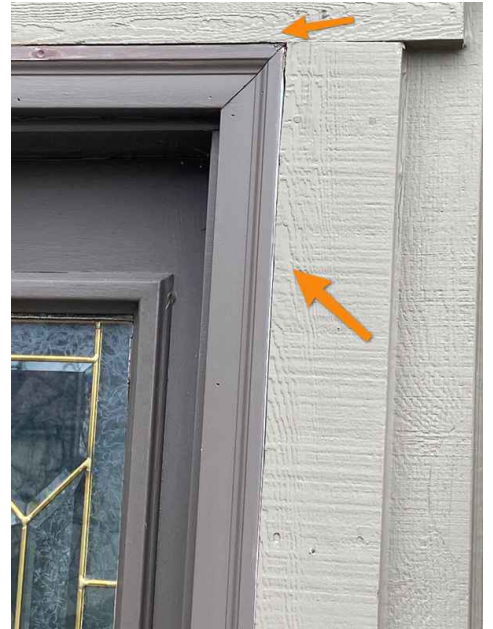
4.2.1 Exterior Door/Egress  
**MISSING CAULKING**

I observed missing caulking at the front exterior door.

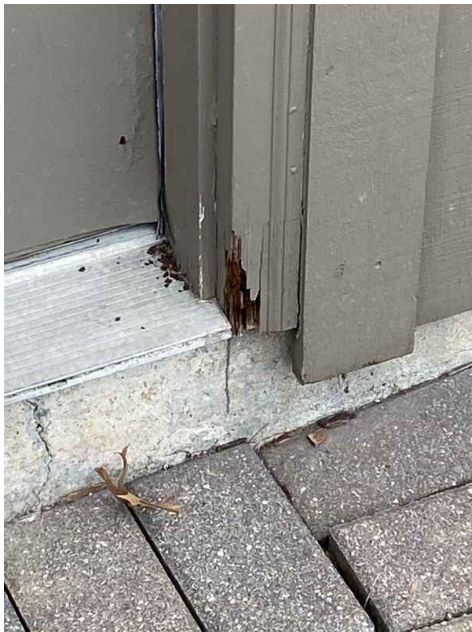
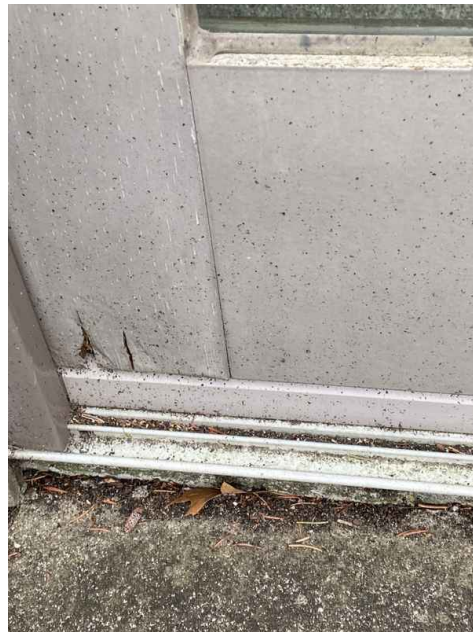
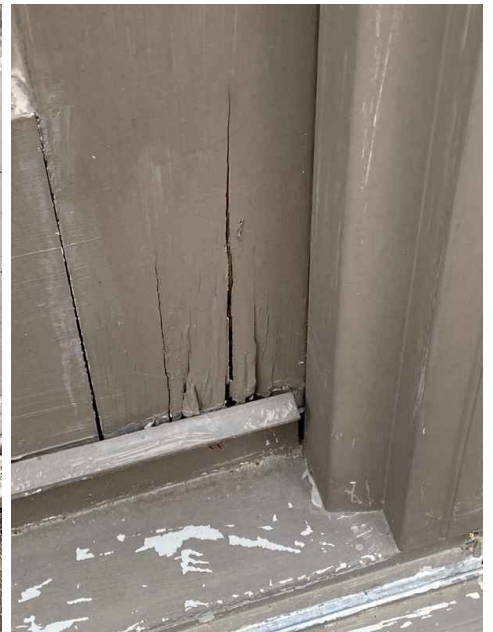
4.2.2 Exterior Door/Egress  
**WOOD ROT AT DOOR**

I observed wood rot at a/an exterior door(s). Further evaluation and correction is recommended.

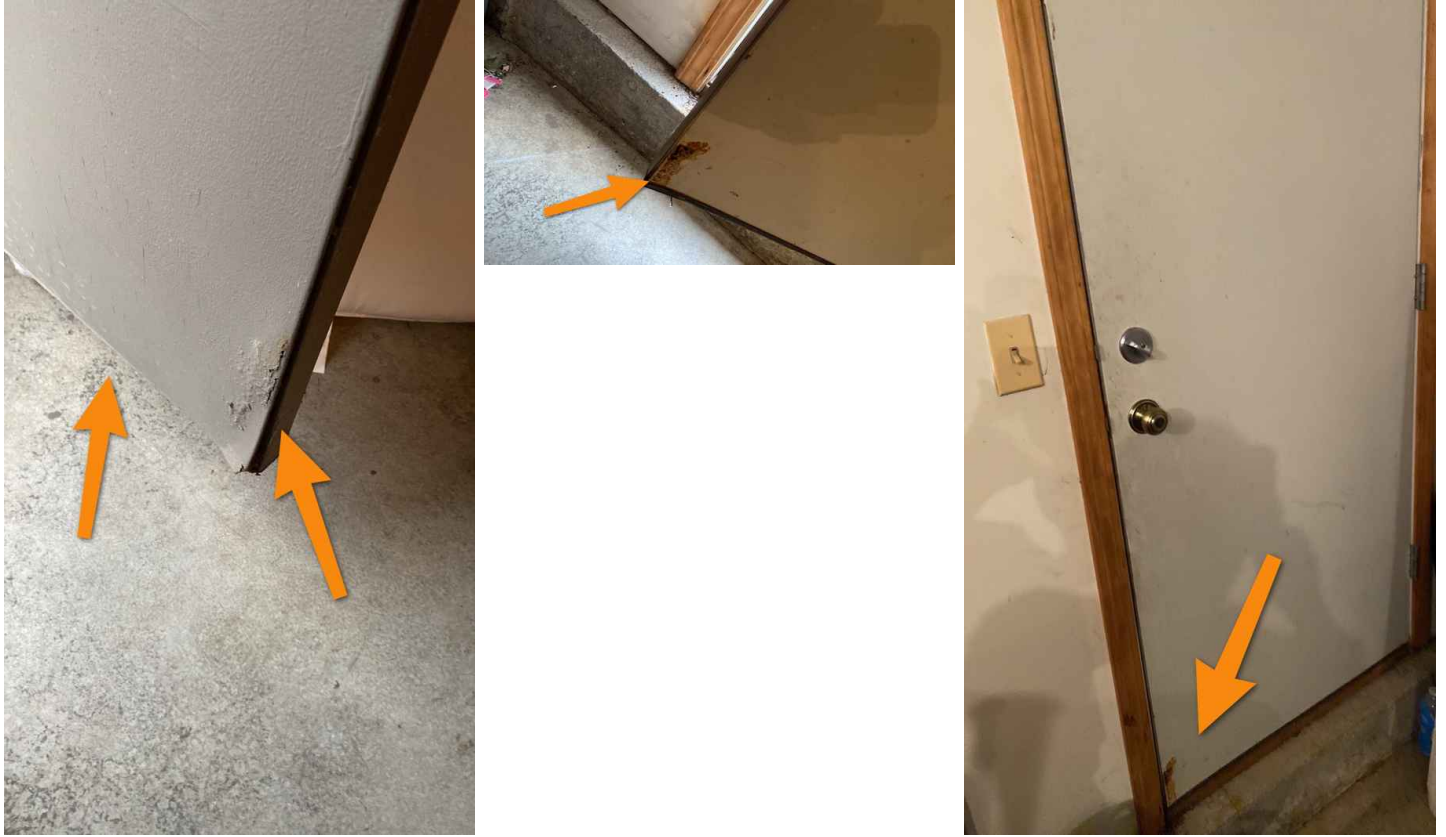
4.2.4 Exterior Door/Egress  
**STEEL DOOR DEFECT**

It was observed that the steel entrance door in the garage is rusted and in need of repair or replacement.

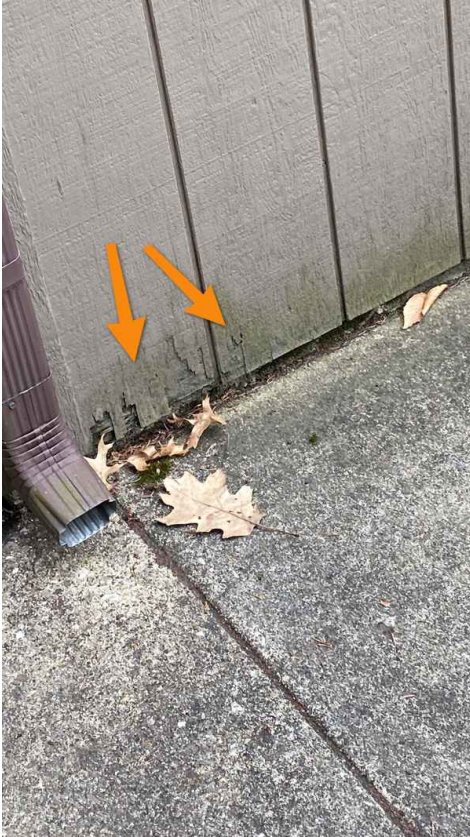
Siding at Basement Patio

**WALL COVERING DEFECT**

I observed area of wood rot in several place at the exterior of the home.

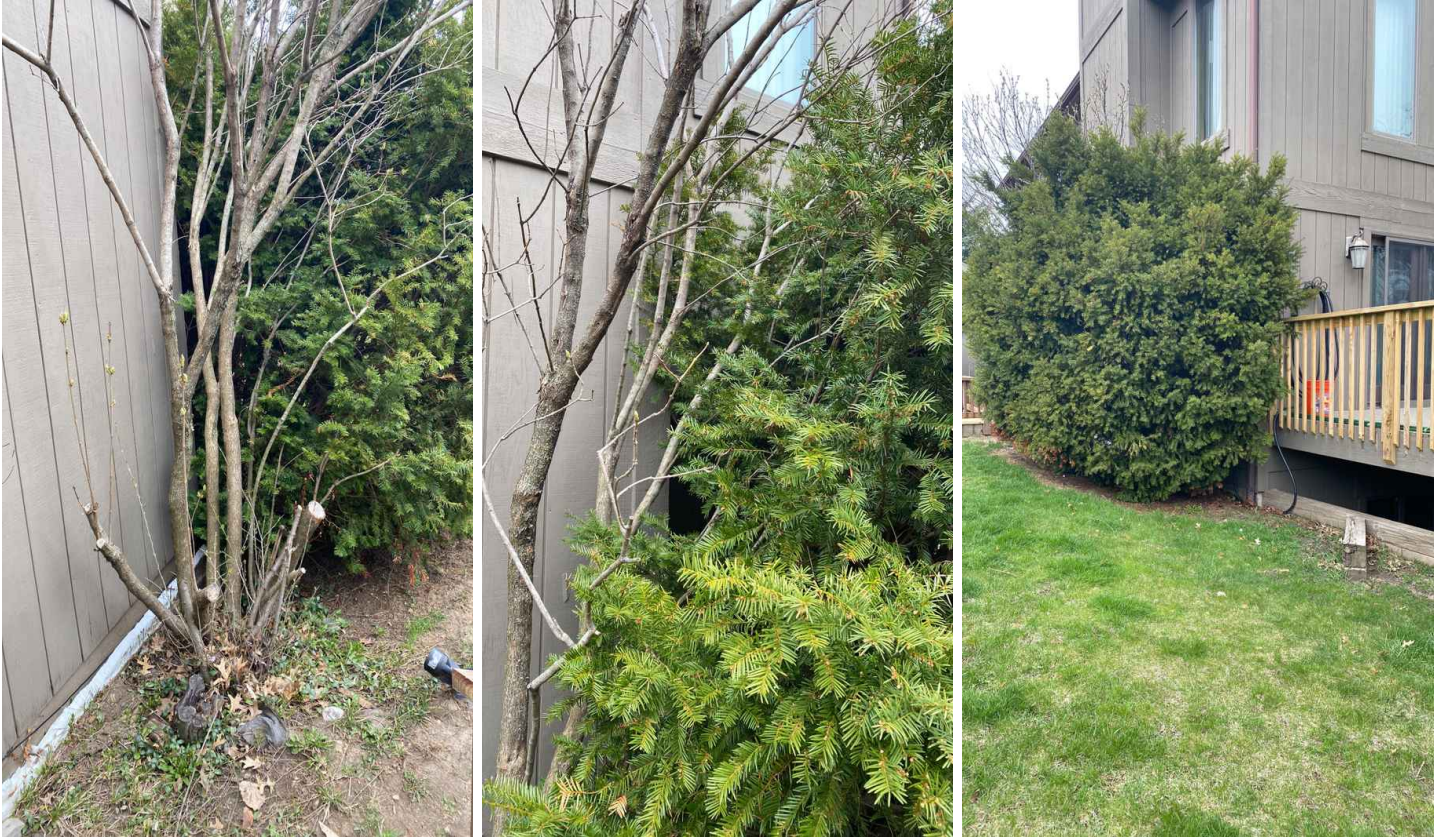
##### **DENSE VEGETATION**

I observed dense vegetation around the house in areas. This condition limited and restricted my visual inspection. Dense vegetation and landscaping up against or near the house foundation and exterior walls may be prone to water penetration and insect infestation.

Trimming, pruning and some landscaping is recommended.

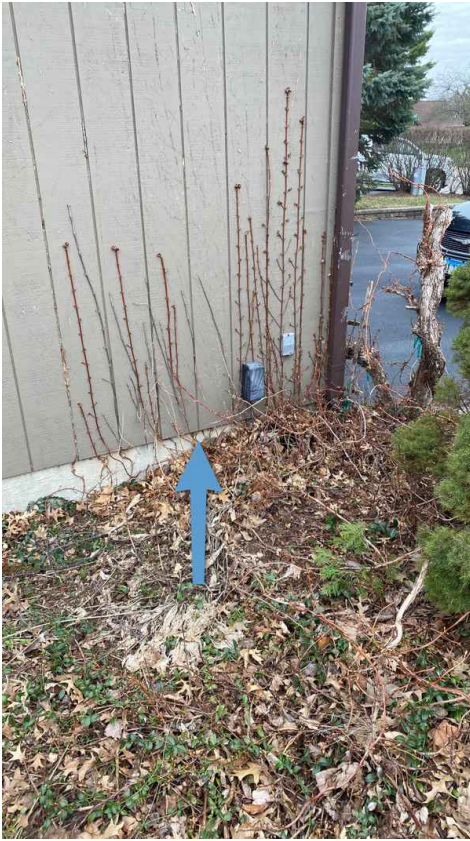
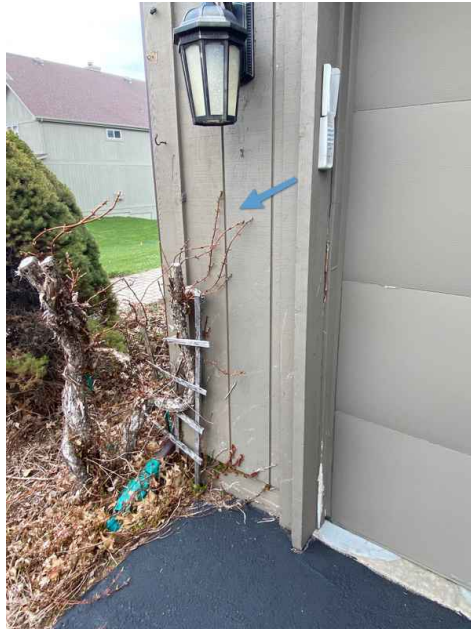
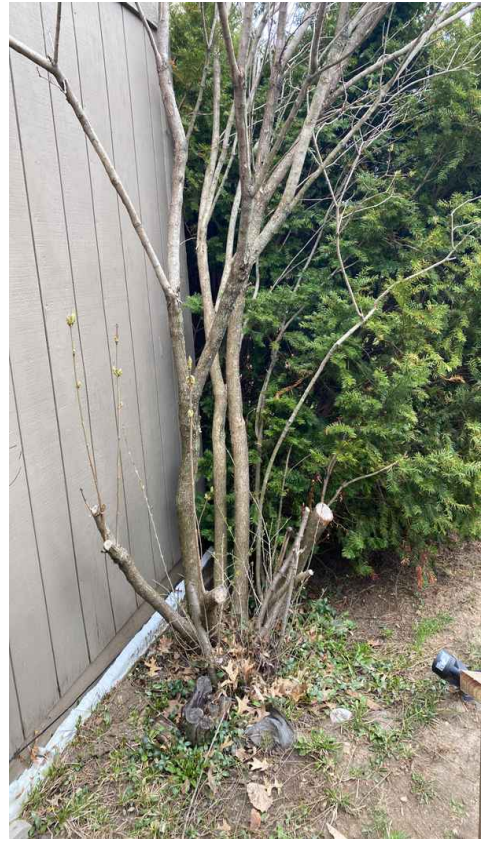
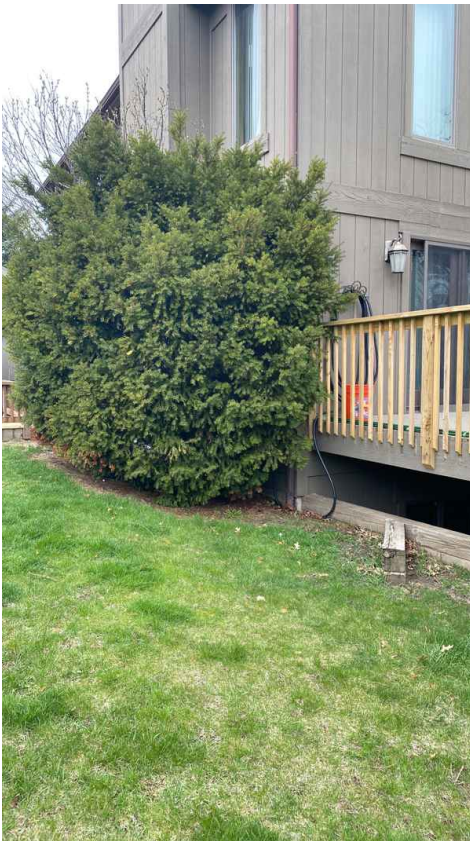
4.5.3 Vegetation, Surface Drainage, Retaining Walls & Grading  
**VEGETATION GROWTH DEFECT**

I observed vegetation growth on the siding of the house. It is recommended that it be removed as the plants hold water which can cause moisture damage especially on the exterior wood siding.

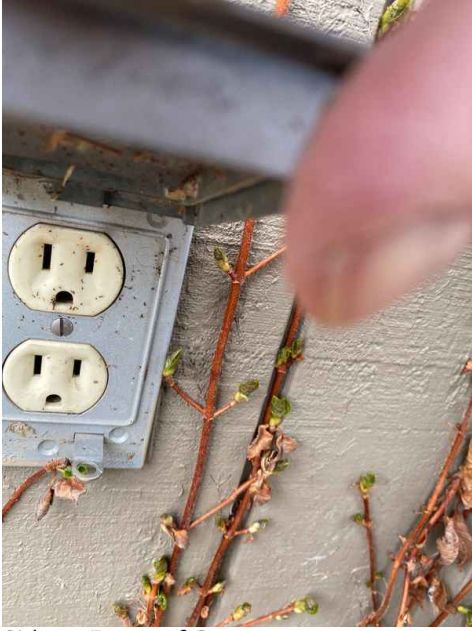
Side at Front of Garage

4.6.1 GFCIs & Electrical  
**NO GFCI PROTECTION**

I observed that the exterior outlets are not GFCI Protected or non-operable.

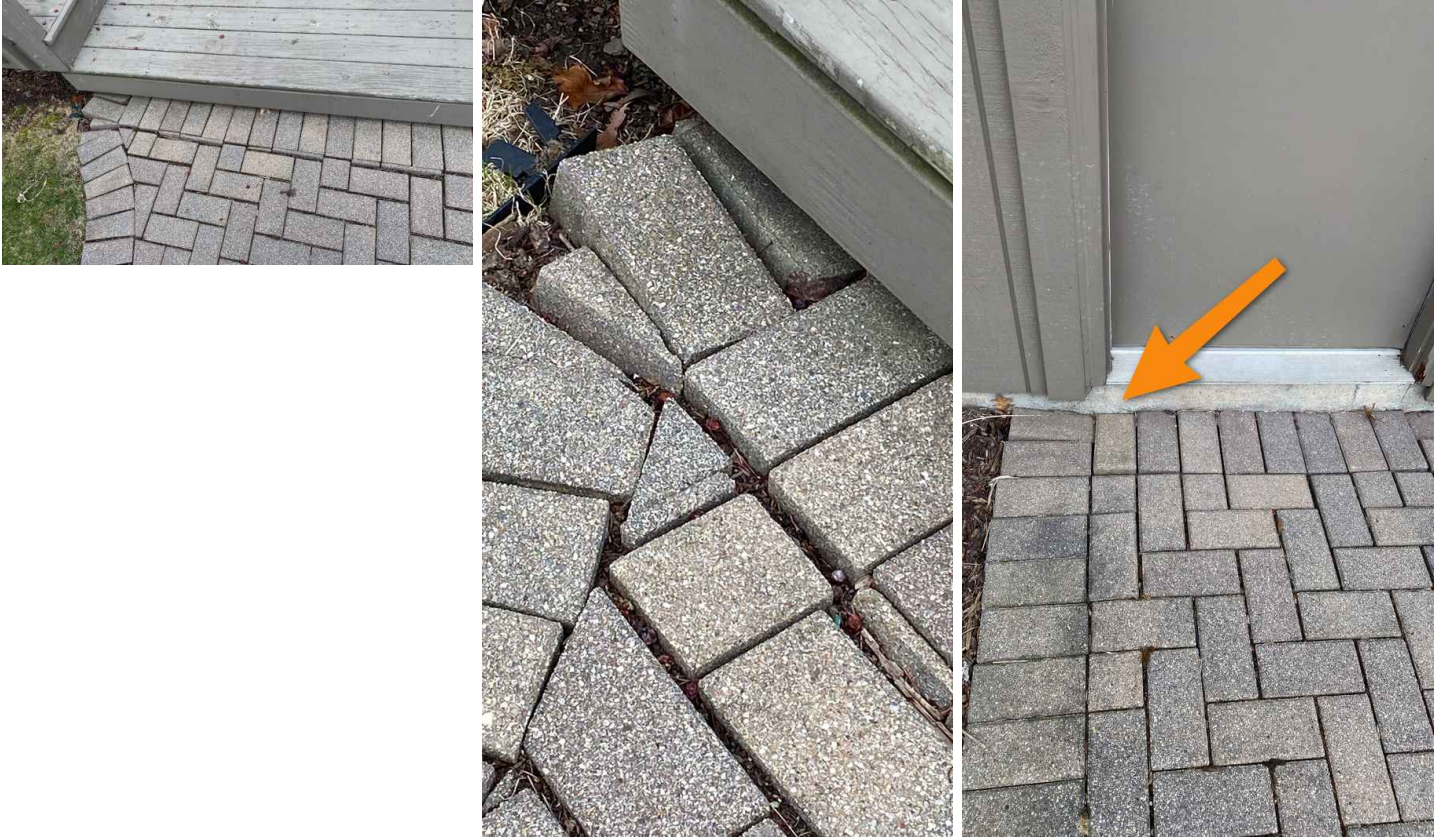
Brick Pavers at Side Garage Door

**BRICK PAVER DEFICEINCY**

It was observed that the brick pavers at the front entrance deck have settled and are moving out of place. This could pose a trip hazard and further deterioration of the paver walkway will result.

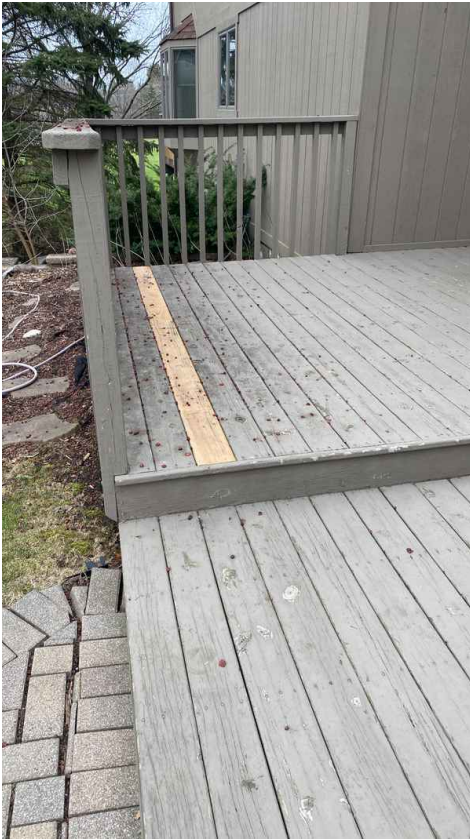
Entrance Deck

##### **FINISH DEFICIENCY**

At the time of the inspection, it was observed that there were deficiencies in the finish of the decks and stairs. It is recommended that the deck and stairs be thoroughly cleaned and refinished to prevent deterioration. This is especially important on the front deck with the green algae and the areas that have been repaired. This shows that there is moisture in this area which someone may slip on and if not attended to will lead to wood rot and costly repairs.

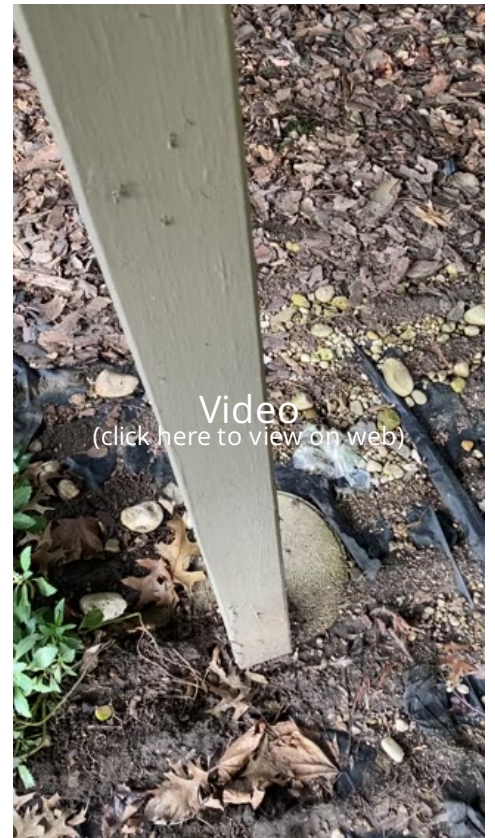
Structural Defect

4.9.1 Porches, Patios, Decks, Balconies & Carports  
**DECK - INADEQUATE STRUCTURAL COMPONENT**

I observed a structural defect at the deck. The deck's structural condition is inadequate. This is a major defect.

Correction and further evaluation of the deck is recommended.

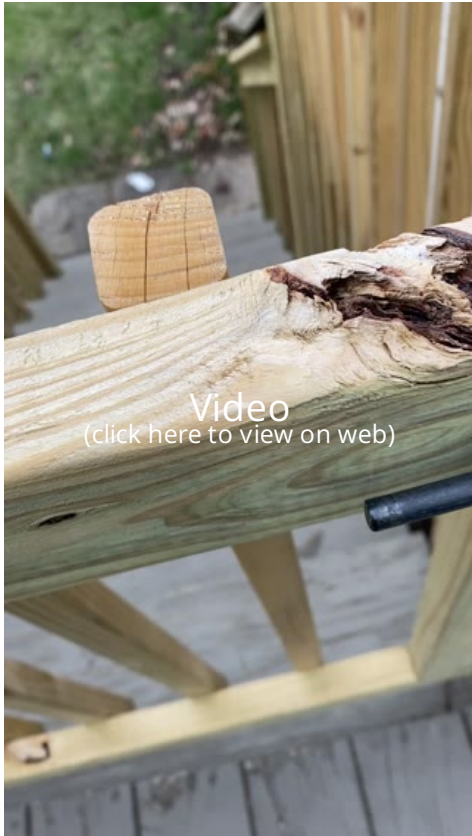
Gate at Rear Deck

### DECK GATE DEFICEINCY

The top board at the gate has a knot in it with sharp edged. It is recommended that this board be replaced. The gate also is not level and pinches at the top.

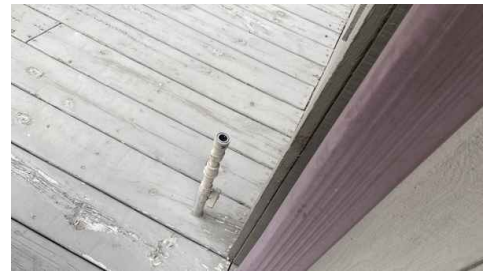
Gas Line Protruding Through Deck Flooring

**GAS LINE DEFECT**

It was observed that there is a gas line sticking up through the deck floor. This line although it has the gas valve turned off it should be capped off especially with young children around! This is a potential fire hazard! This should be done on the underside of the deck. As it is now it is also a trip hazard. Recommend a qualified professional do further investigation and repairs.

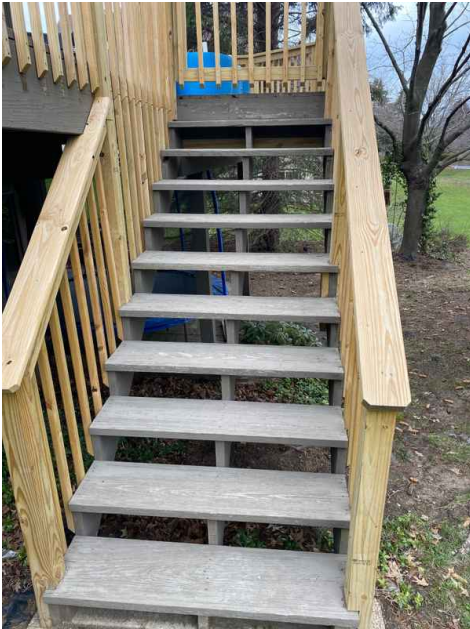
**HANDRAIL NOT GRASPABLE**

I observed the deck handrails are not graspable. This condition is a safety hazard. Correction and further evaluation are recommended. Also, all repairs done to the railings, guards & handrails need a protective finish coat or staining.

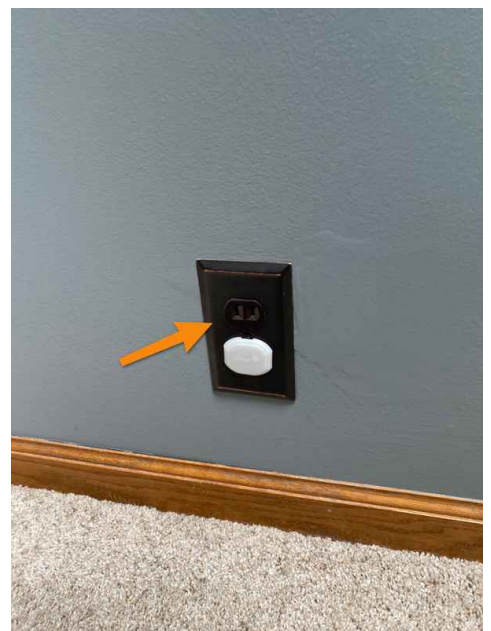
Master Bedroom

5.7.2 Switches, Outlets & Cover Plates  
**ELECTRICAL OUTLET DEFECT**

I observed an outlet(s) that were defective. They were either obsolete, damaged, not wired correctly, not mounted securely, or worn and required replacement. The outlets in the master bedroom have two prongs and do not have a third grounding port. This is a shock hazard. It is recommended that a qualified electrician do further evaluation and correction.

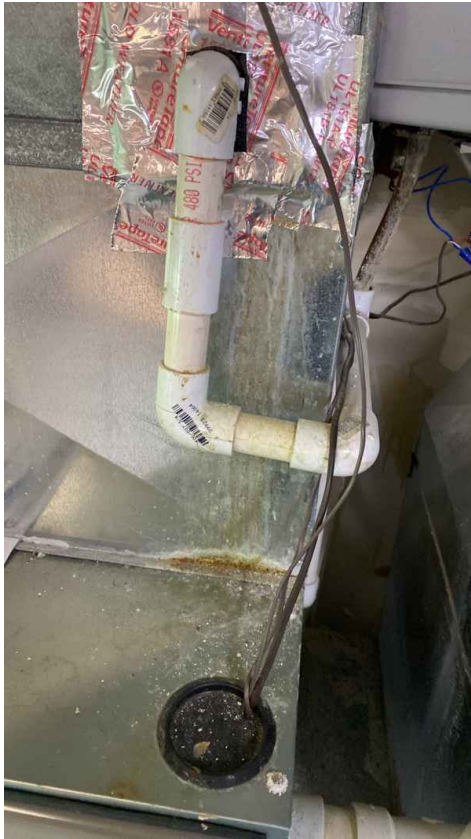
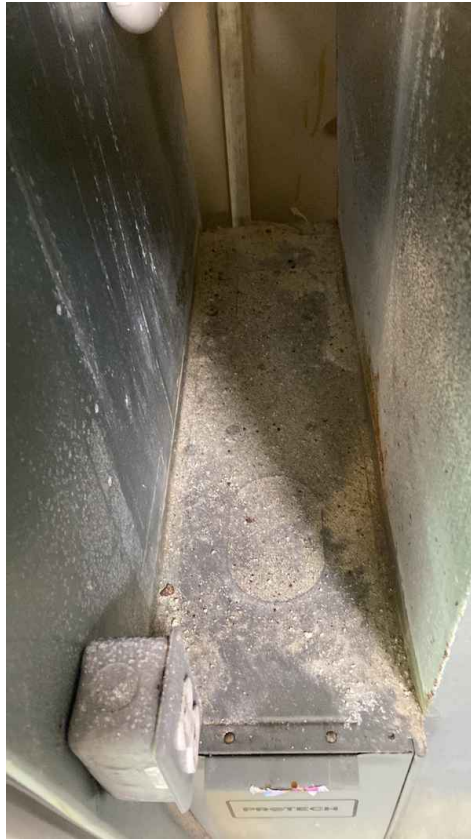
**DEFECT AT CONDENSATE**

I observed effervescence at the air conditioner's condensate drainage line. I recommend a qualified HVAC technician do further evaluation and correction as needed.

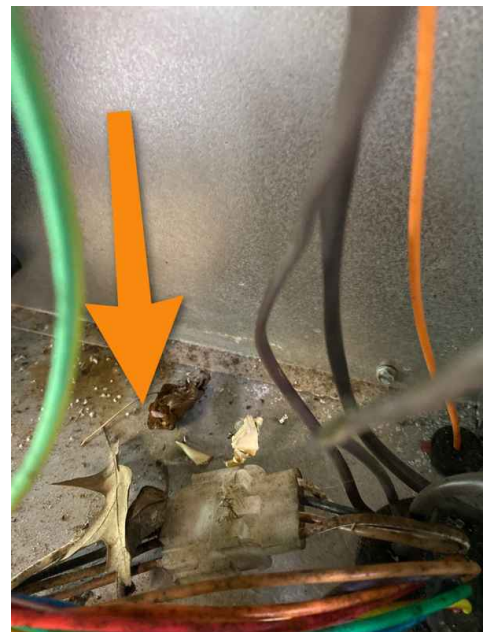
Debris Inside of Furnace

**SERVICE TAG INDICATES DELAYED MAINTENANCE**

I observed indications of delayed maintenance at the heating system. There was not a service tag posted anywhere around the furnace. It is recommended that the system be cleaned and inspected by a HVAC professional every year.

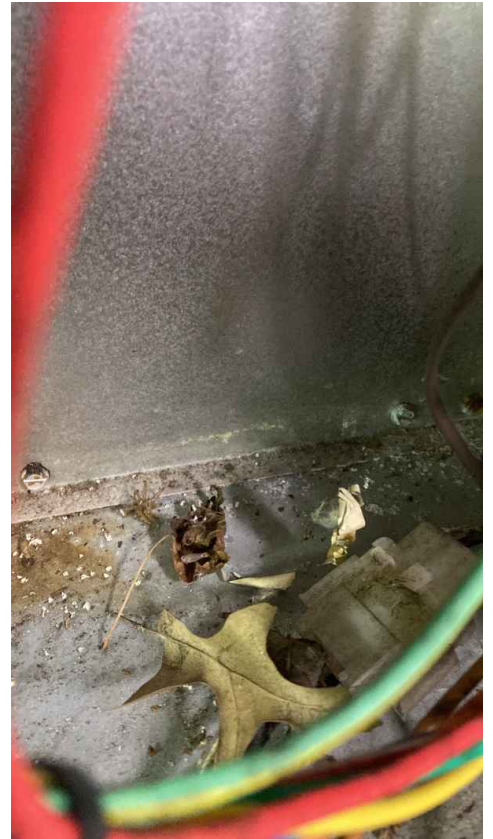
**DEFECT AT HEATING SYSTEM**

I observed a defect at the heating system.

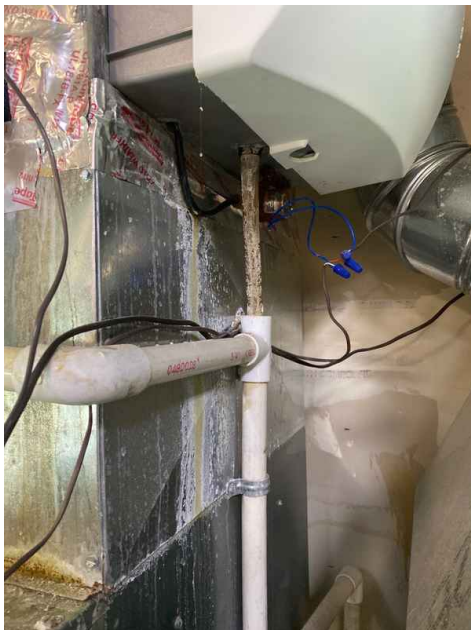
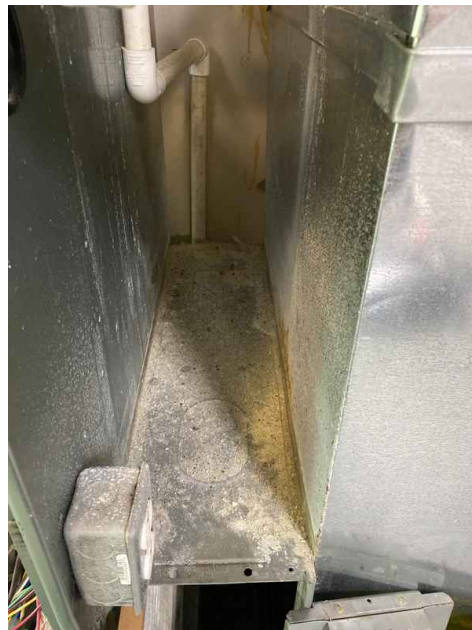
7.1.3 Heating System Information  
**HUMIDIFIER MAINTENANCE**

It was observed that the filter in the furnace humidifier was dirty. It is recommended that the filter be cleaned or changed.

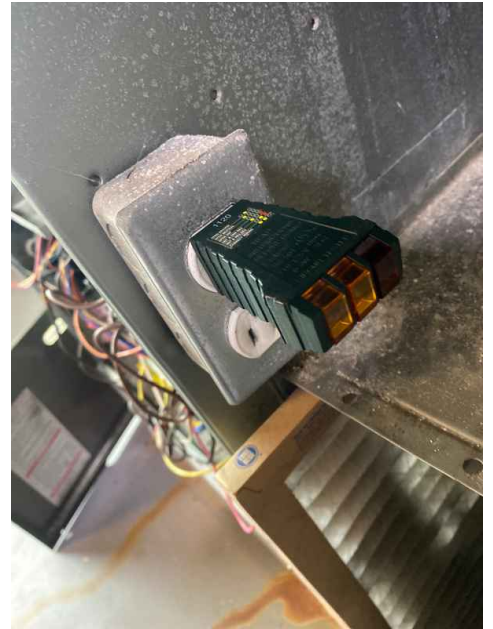
7.1.4 Heating System Information  
**ELECTRICAL OUTLET DEFECTS**

I observed that there was no power at the furnace outlet. This outlet should also be GFCI protected. It is recommended that a qualified professional do further evaluation and correction.

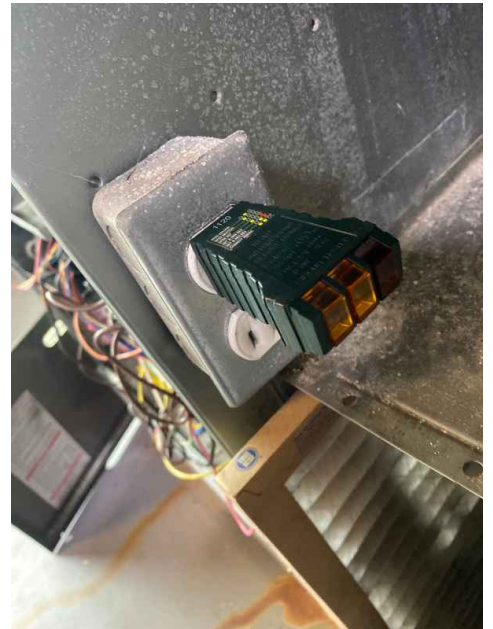
Outlet at Furnace

### **ELECTRICAL DEFECT AT FURNACE**

It was observed that the electrical outlet at the furnace had no power to it. It is recommended that a qualified HVAC technician or electrician do further a evaluation and correction.

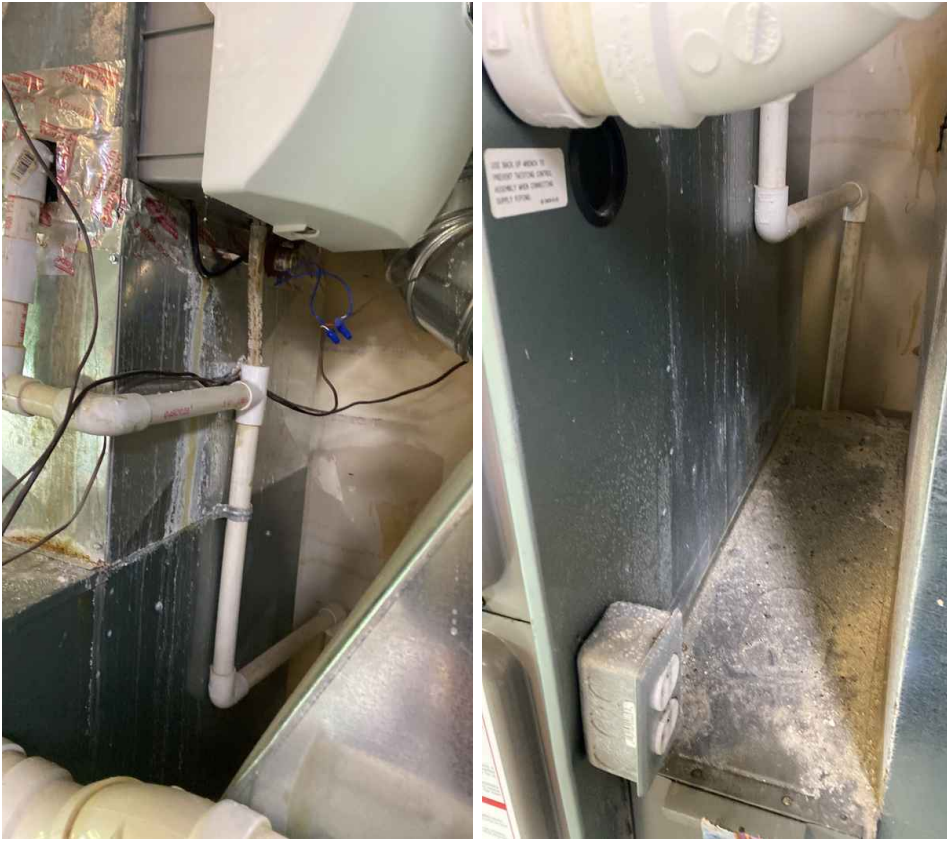
### **HUMIDIFIER DEFECT**

It was observed that there is a defect at the furnace humidifier. There is considerable effervescence coming down the side of the furnace and also from the condensate tube from the furnace. It is recommended that a qualified HVAC technician do further evaluation and corrections.

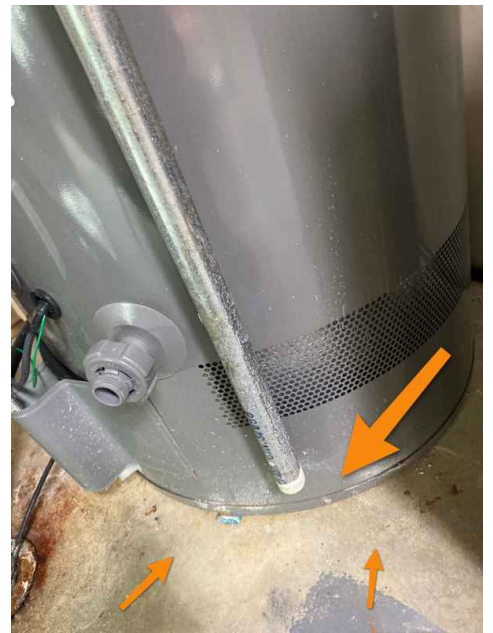
TPR Valve Discharge

### DEFECT AT TPR VALVE DISCHARGE

I observed a defect at the TPR (temperature, pressure, and relief) valve. The discharge pipe that serves a temperature pressure relief valve must:

- Not be connected to the drainage system.
- Discharge through an air gap located in the same room as the water heater.
- Not be smaller than the diameter of the outlet of the valve.
- Serve a single relief device.
- Discharge to the floor.
- Discharge in a manner that does not cause personal injury or structural damage.
- Discharge to a termination point that is readily observable.
- Not be trapped.
- Be installed so as to flow by gravity.
- Terminate no more than 6 inches above the floor or flood level rim of the waste receptor. And not less than 2 times the discharge pipe diameter.
- Not have valves or tee fittings.
- Be constructed of materials listed or rated for such use.
- Be one nominal size larger than the size of the relief valve outlet, where the relief valve discharge piping is installed with insert fittings.

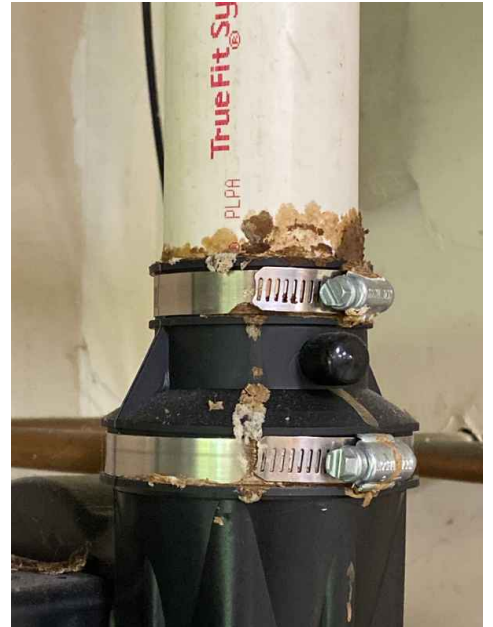
**DEFECT AT VENT CONNECTION PIPE**

I observed a defect in the vent connection pipe of the hot water source. It is recommended that a qualified plumber do further evaluation and repair.

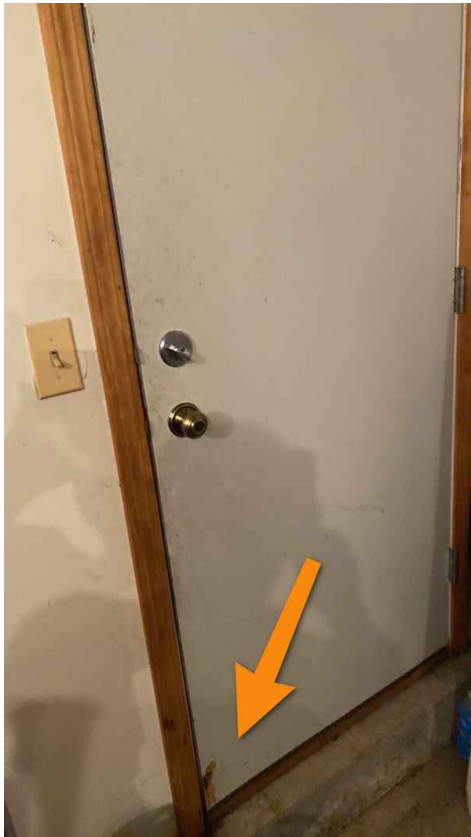
Garage

**DAMAGED DOOR**

I observed damage to the door. The steel entrance door is rusting through. Recommend a qualified carpenter/contractor to replace the door.

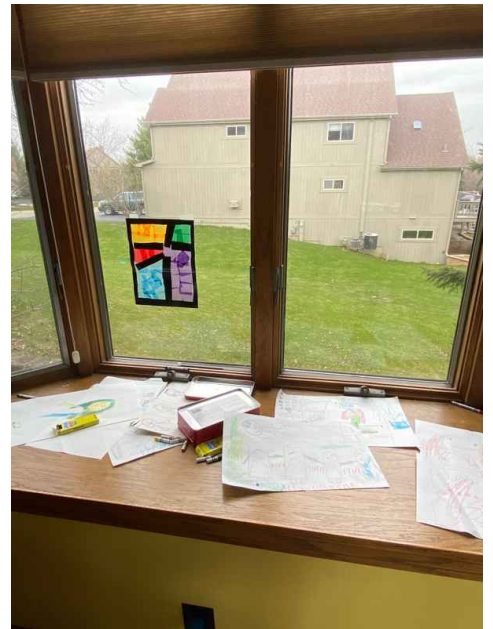
**MISSING WINDOW SCREEN**

I observed a missing window screen.

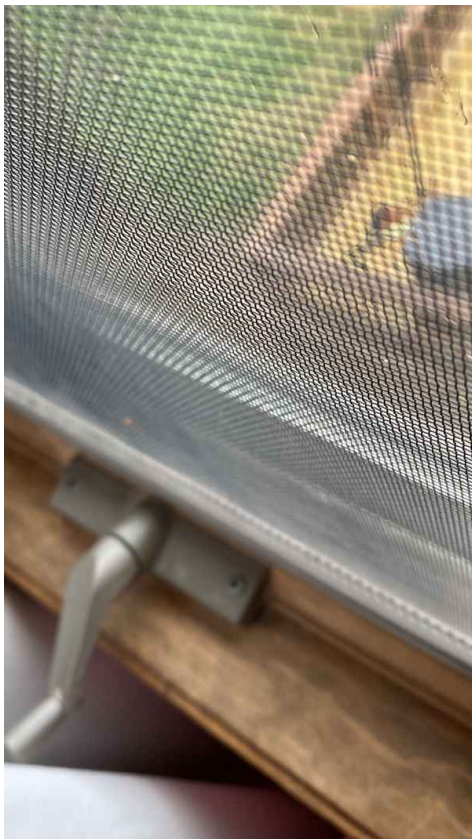
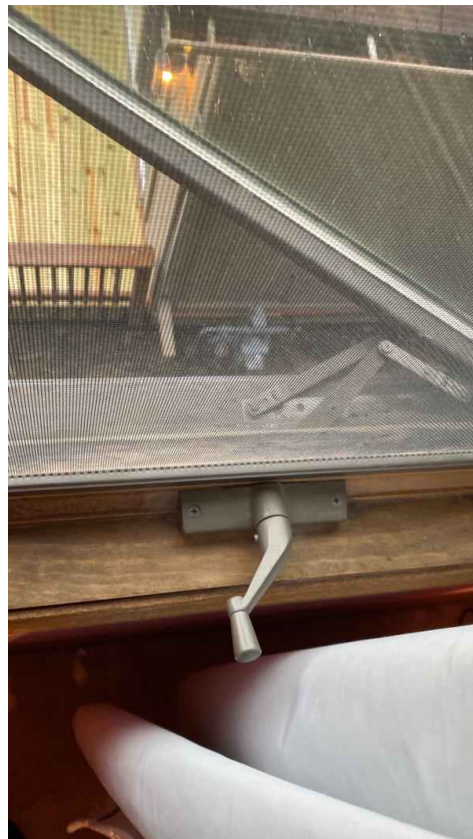
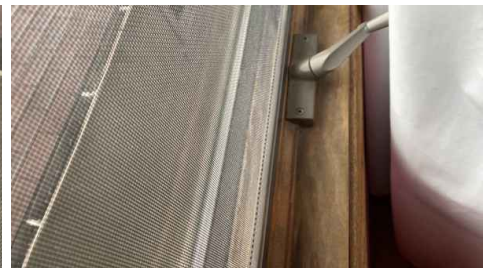
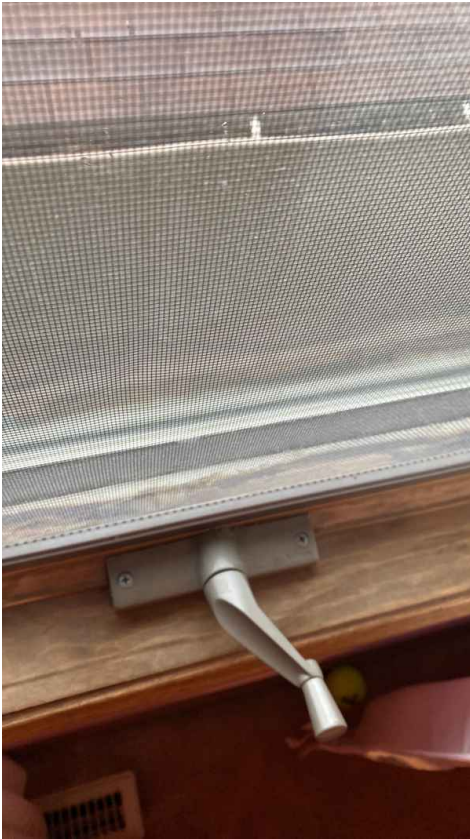
**WINDOW FINISH DEFECTS**

It was observed the most of the windows in the house are thermal pane wood casement windows. It was observed that most of the windows have the finished deteriorating on the exterior side of the bottom rail. Because this part of the window is exposed to heating/cooling and moisture the finish has broken down. I did not observe any wood rot at this time. I recommend that a qualified painting contractor do further evaluations and repairs.

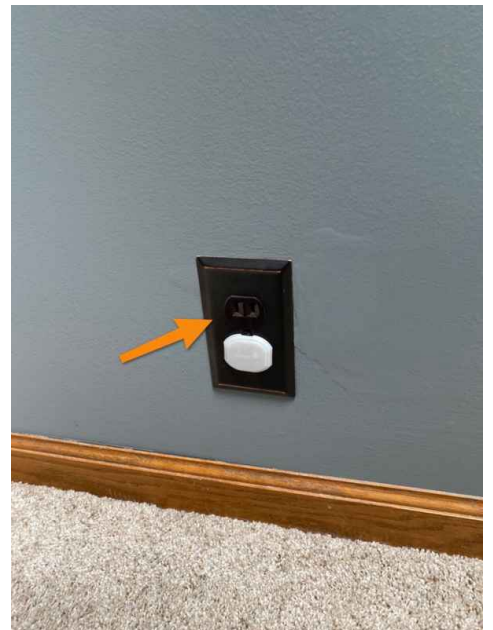
Master Bedroom

10.3.1 Switches, Fixtures & Receptacles  
**MISSING GROUND AT RECEPTACLE**

I observed indications of missing, open, or disconnected ground at a receptacle. Hazard.

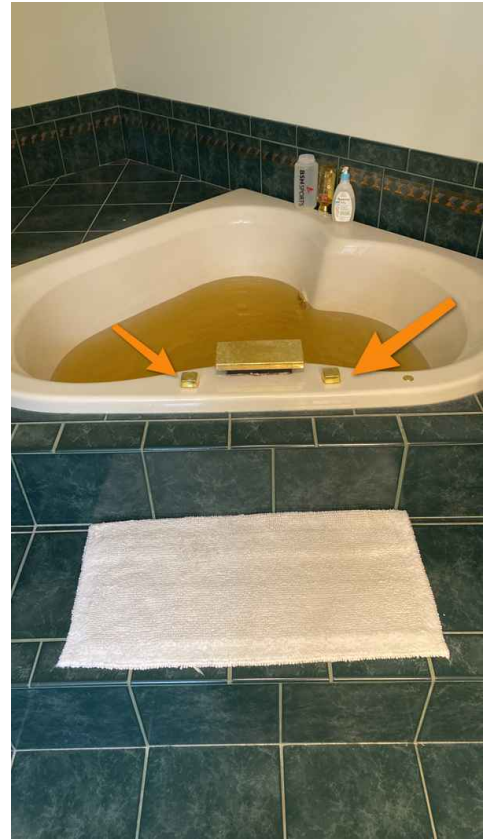
**HOT & COLD WAS REVERSED**

I observed that the hot and cold water supply at the fixture was reversed. The standard for a fixture is to have the hot water supply controlled by the valve or handle on the left and the cold water by the right-side handle. This was observed at the shower control and the jet tub controls.
