SUMMARY

1234 Main Street Huntley IL 60142

Michael Hetzel  
InterNACHI Certified Professional  
Inspector  
Wisdom Home Inspection Services LLC  
(224) 817-1511  
Mike@WisdomHIS.com

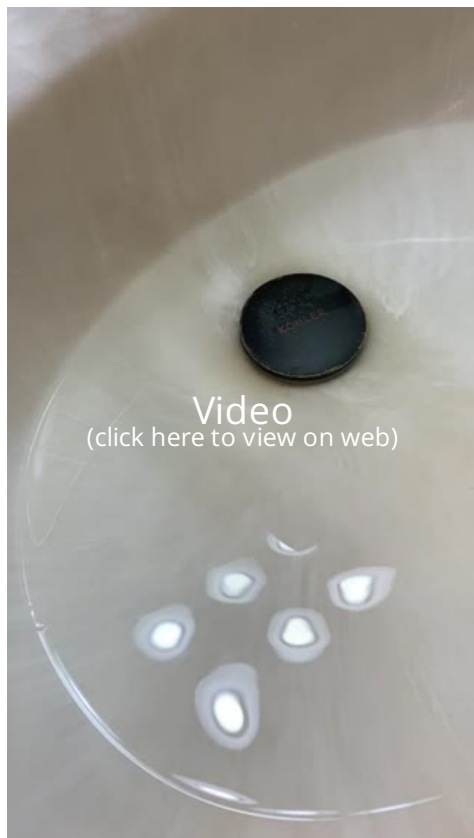
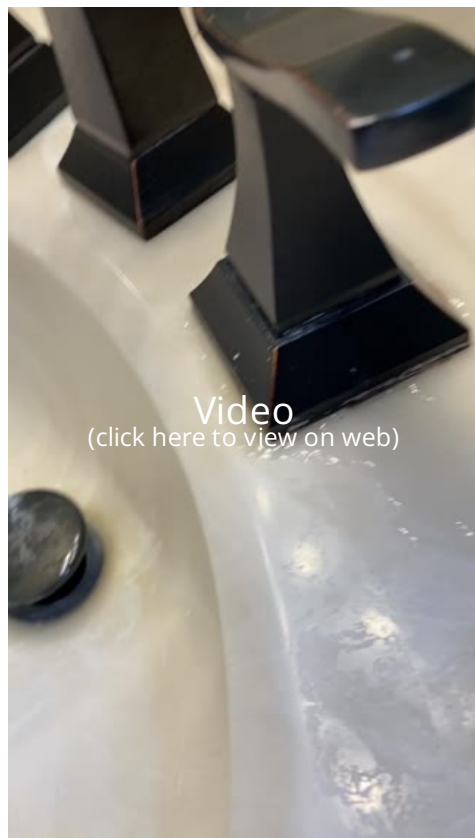
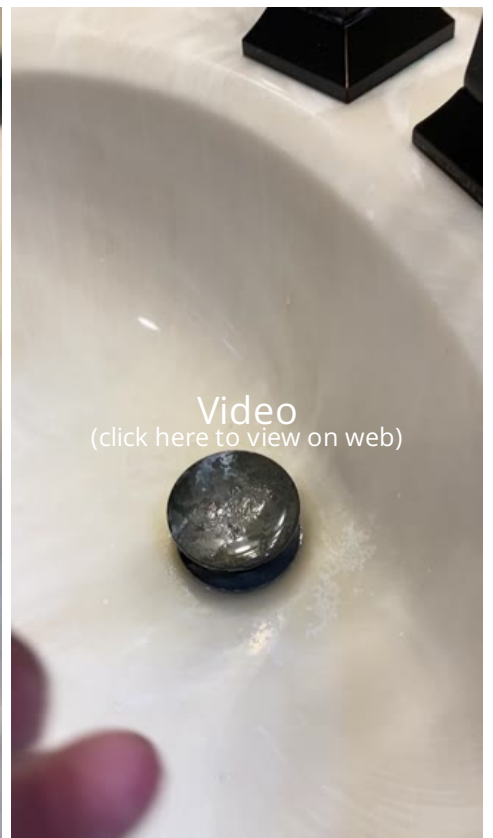
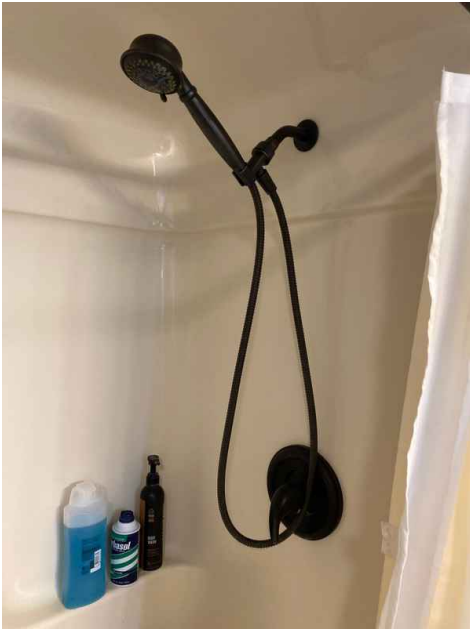
**LAVATORY DRAIN DEFECT**

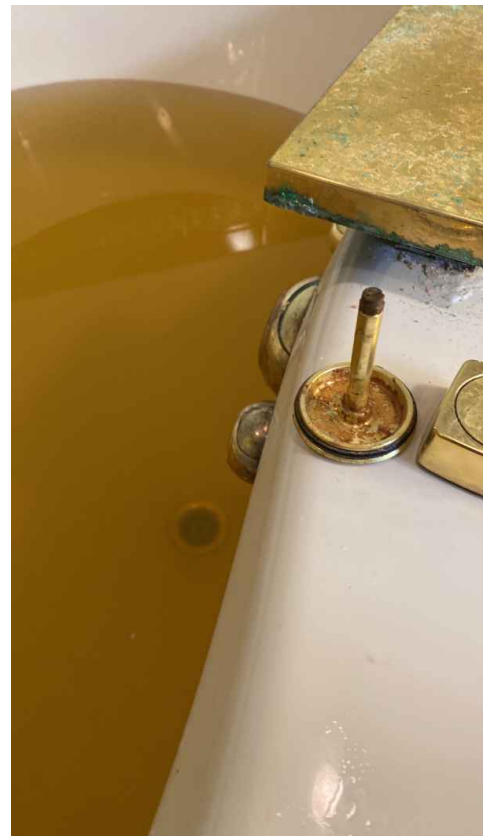
#### **TUB STOPPER DEFECT**

I observed that the tub stopper does not work. Defect.

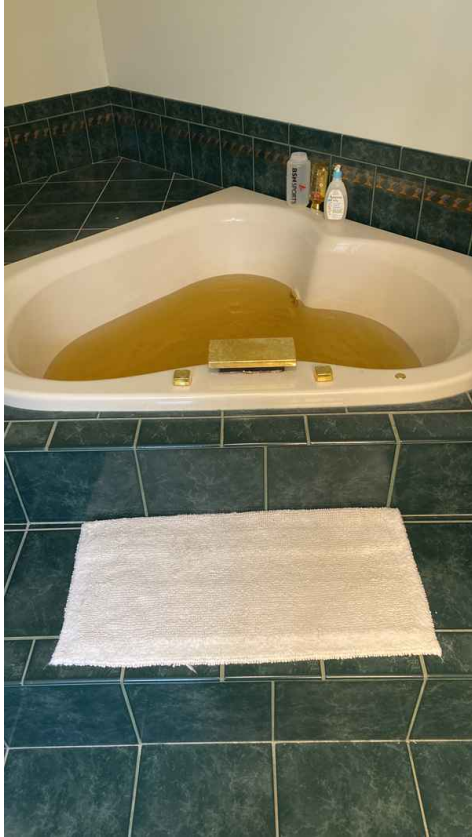
Jet Tub in Master Bath

**JET TUB DEFICIENCY**

It was observed when the jet tub was full of water and normal operating controls were used, the jets did not operate. This is a material defect. The orange water is due to the water softener being removed and the water is not conditioned. It is recommended that qualified professionals do further evaluation and repair.

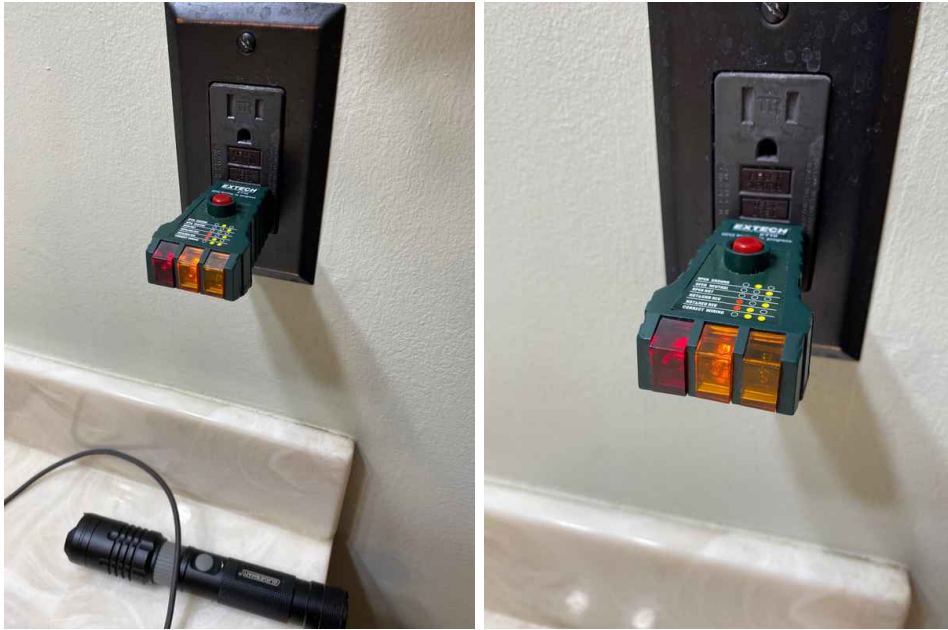
**GFCI IMPROPERLY WIRED**

I observed a defect at the GFCI in the bathroom. It was not properly wired. There is not GFCI protection at either receptacle. This is a safety hazard.

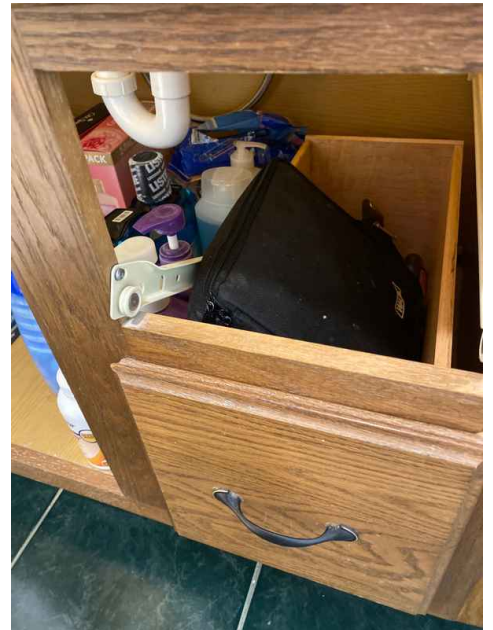
11.7.1 Cabinetry, Ceiling, Walls & Floor  
**CABINET DAMAGE**

I observed indications of damage at the bathroom cabinetry.

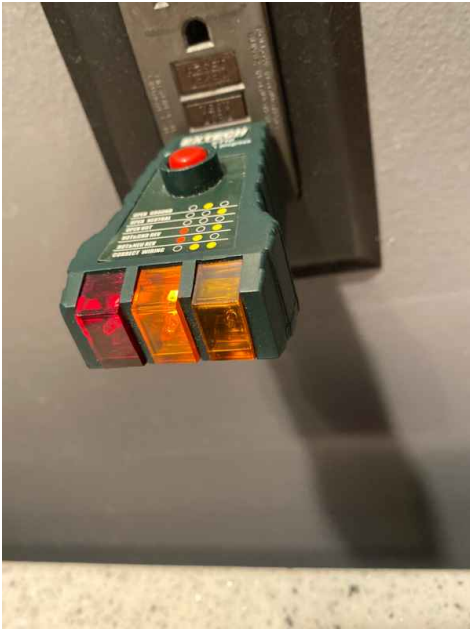
12.5.1 GFCI & Electric in Bathroom  
**GFCI IMPROPERLY WIRED**

I observed a defect at the GFCI in the bathroom. It was not properly wired.

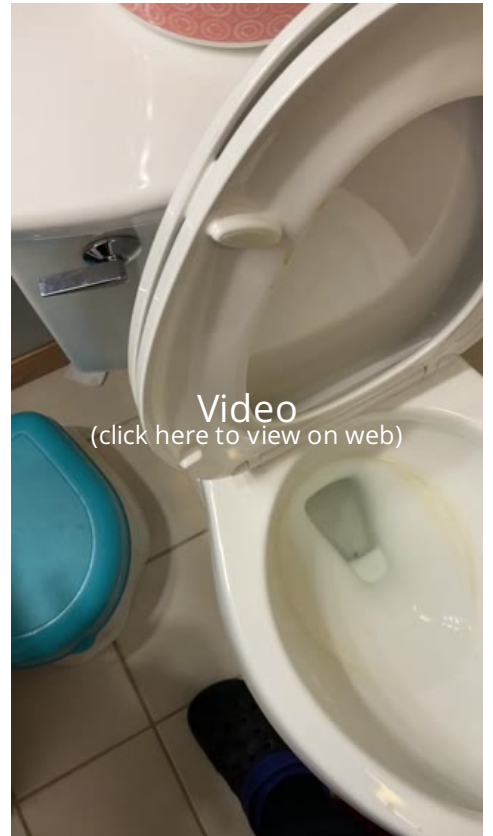
**TOILET MOUNTING DEFECT**

I observed that the basement toilet was loose and leaking on to the floor.

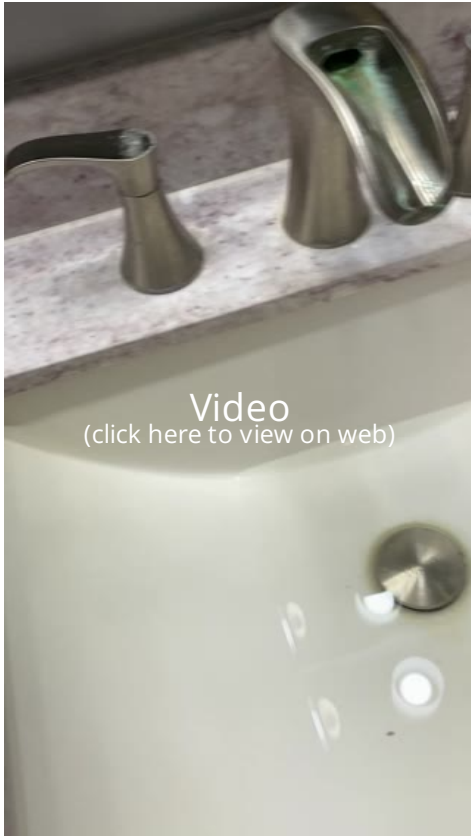
**LAVATORY DRAIN DEFECTS**

It was observed that there were several defect witnesses the laboratory drains.

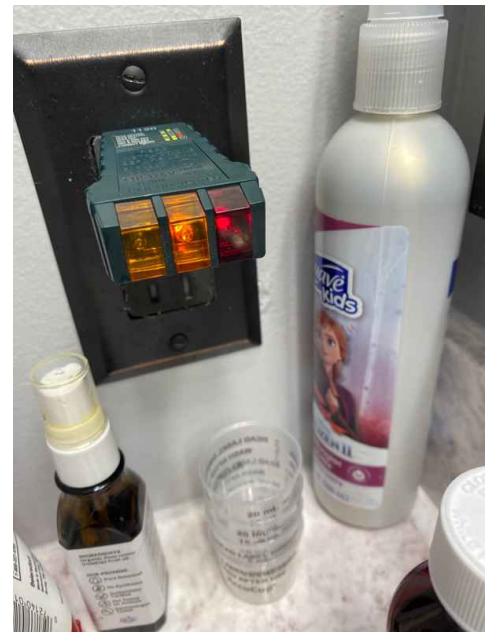
Bathroom #4

#### 14.4.1 GFCI & Electric in Bathroom **GFCI IMPROPERLY WIRED**

I observed a defect at the GFCI in the bathroom. It was not properly wired. This outlet had hot & neutral reversed. Also the outlet was placed upside down. This is a potentially dangerous situation as there is no GFCI protection. It is recommended that a qualified electrician do further evaluation and corrections.

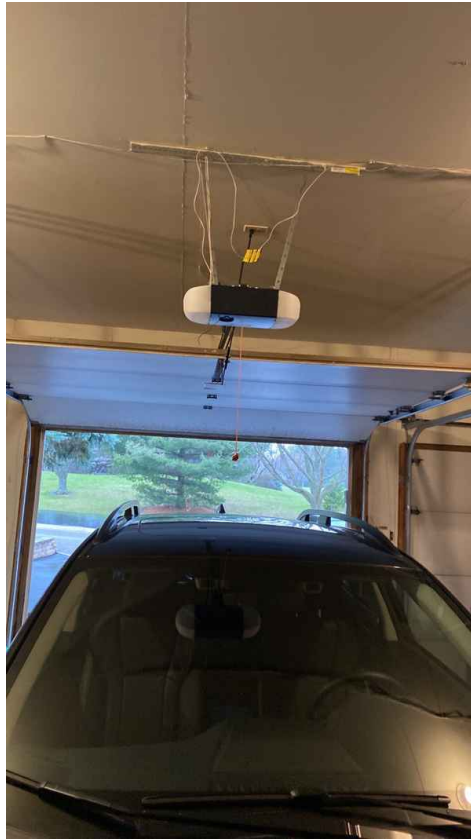
Garage Door #2

#### 17.3.1 Garage Vehicle Door Opener **WARNING LABEL DEFECT**

There is a defect at a warning label.

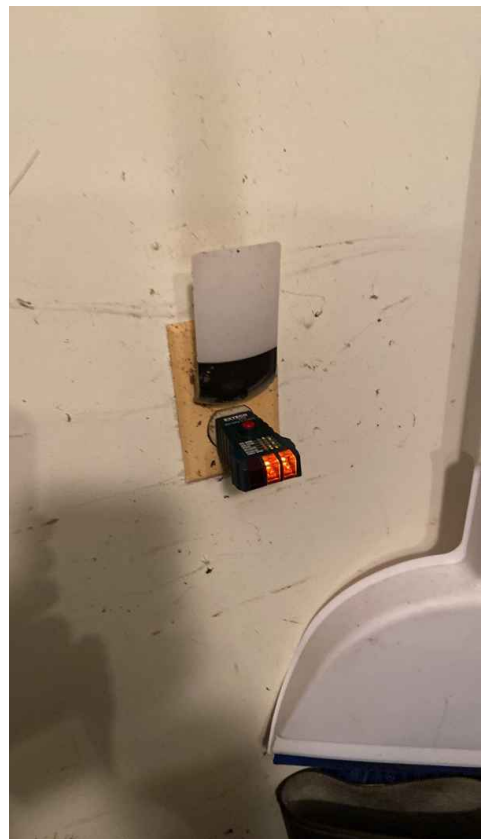
**MISSING GFCI-PROTECTION IN GARAGE**

I observed a receptacle in the GFCI in the attached garage (or ground fault circuit interrupter). When tested it functioned properly.

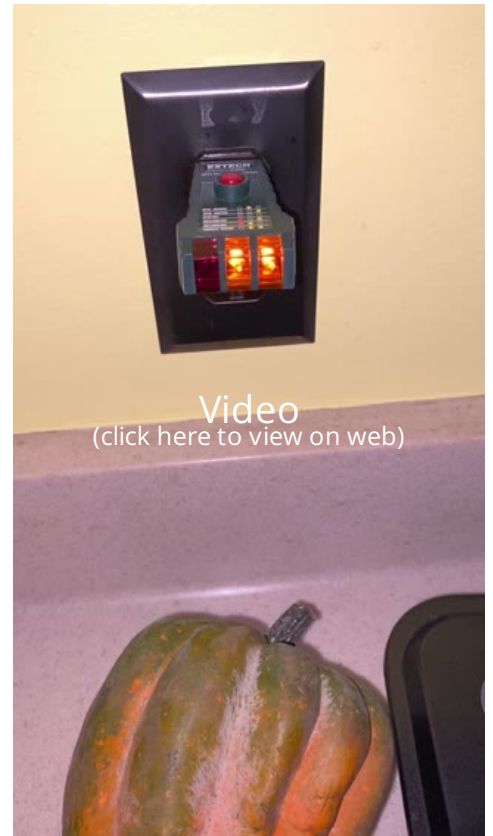
**MISSING GFCI PROTECTION**

I observed indications of missing GFCI protection in the kitchen. All kitchen counter receptacles are required to be GFCI protected.

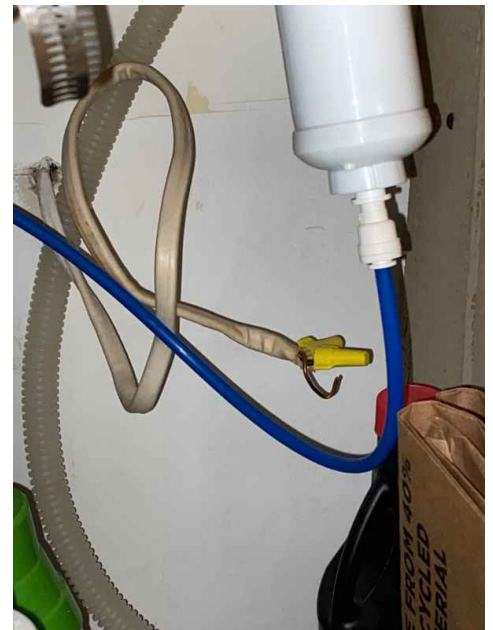
**ELECTRICAL DEFECT**

It was observed that an open NM cable is exposed under the kitchen sink. This is a safety hazard. It is recommended that an electrician do further evaluation and correction.

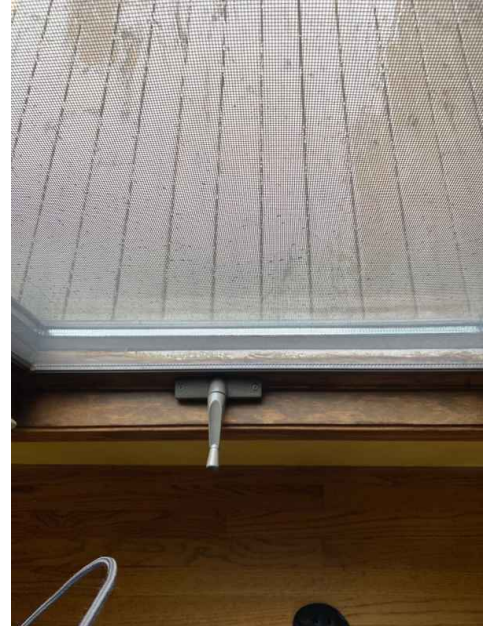
**WINDOW FINISH DEFECT**

I observed that the finish on outside of the windows was peeling away,
