SUMMARY

1234 Main Street Huntley IL 60142

Michael Hetzel  
InterNACHI Certified Professional  
Inspector  
Wisdom Home Inspection Services LLC  
(224) 817-1511  
Mike@WisdomHIS.com

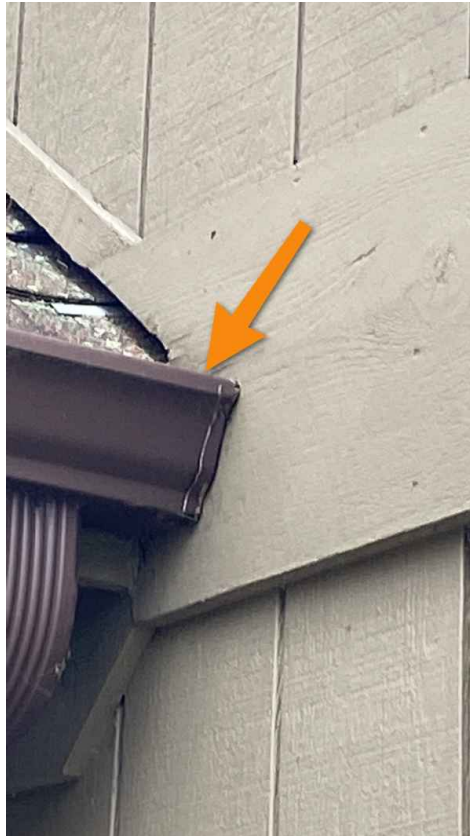
At Front Deck

#### MISSING KICKOUT FLASHING

MINOR DEFECT

I observed a defect at the flashing area called a "kickout." It's missing. Not installed. A kickout flashing "kicks" the roof water away from the house structure and diverts it into a gutter. This missing flashing could lead to hidden moisture intrusion and water damage issues that I would not be able to observe during a visual-only home inspection. A roofing professional is needed to further evaluate and make necessary corrections.

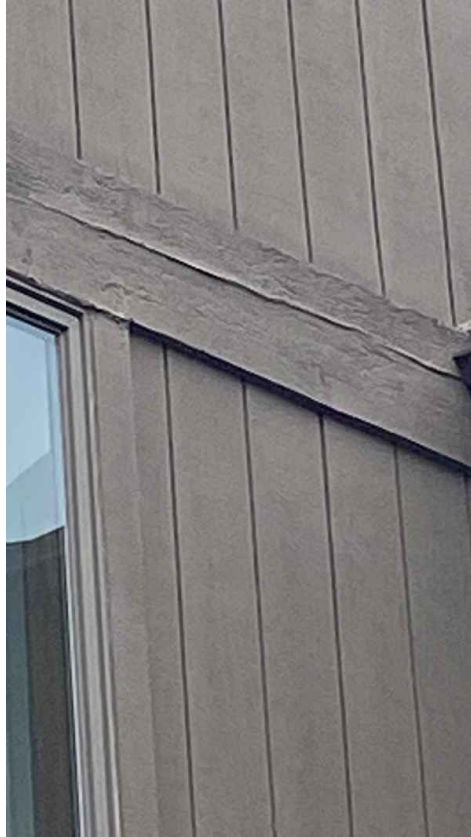
Belly Board above Deck

**WALL COVERING DEFECT**

I observed area of wood rot in several place at the exterior of the home.

MINOR DEFECT

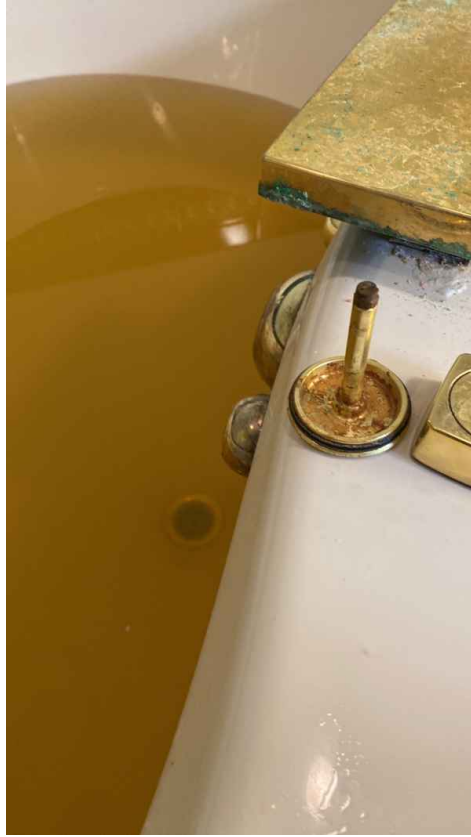
Non-Operational Drain in Jet Tub
